| <b>Brand:</b> | Volvo | <b>Mileage(km):</b> | 233500 |
| <b>Model:</b> | V50 | <b>Number of doors:</b> | 5 |
| <b>Report code:</b> | 4807 | <b>Vehicle height (cm):</b> | |

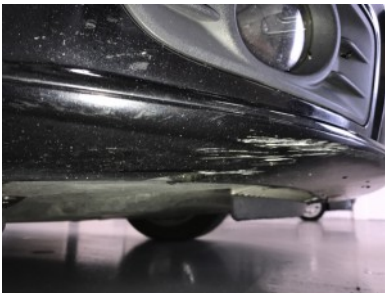
Front bumper - Paint repair

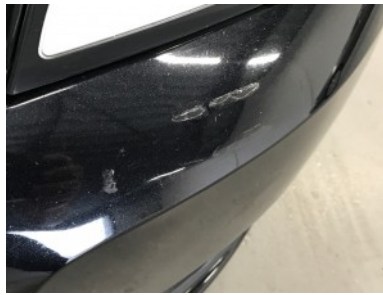
Front bumper - Paint repair

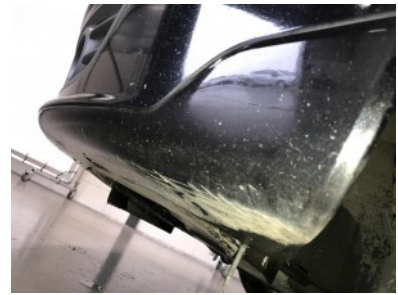
Front bumper - Paint repair

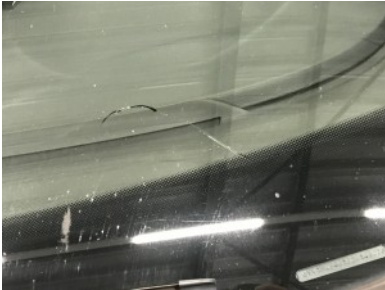
Windscreen - Break

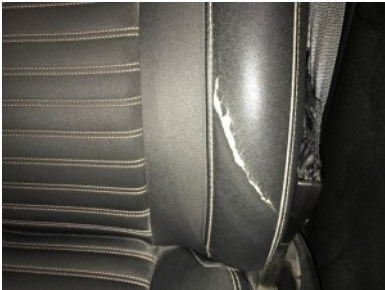
bestuurdersstoel beschadigd.

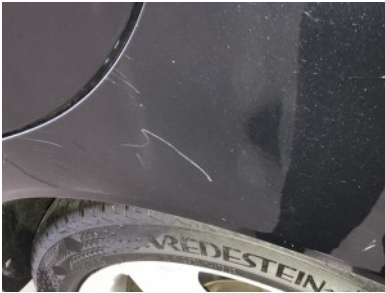
Rear left screen - Paint repair

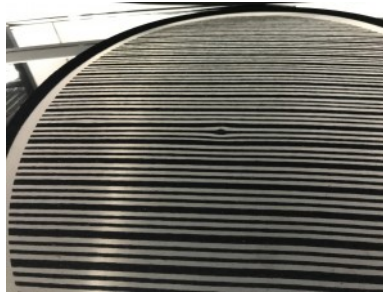
Roof - Restyle deuk(je) en Restyle deuk(jes)
